CONSERVATION MANAGEMENT PLAN

370 Pennant Hills Road, Pennant Hills

Issue D, July 2022

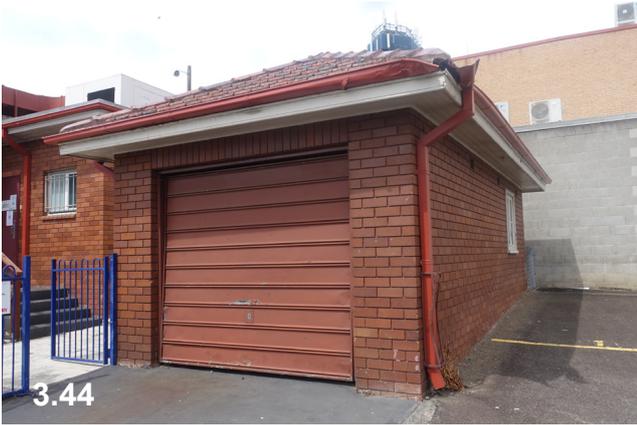
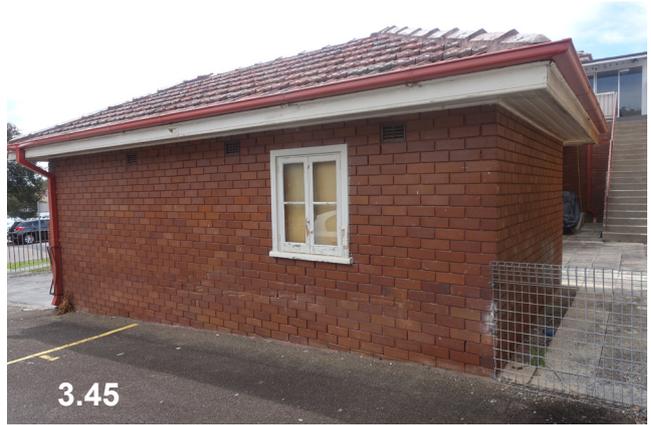
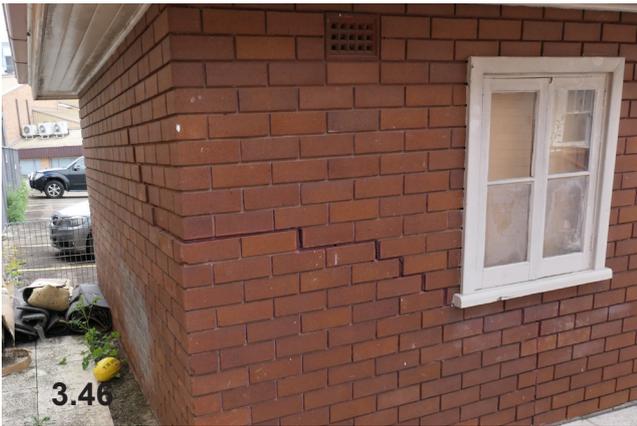
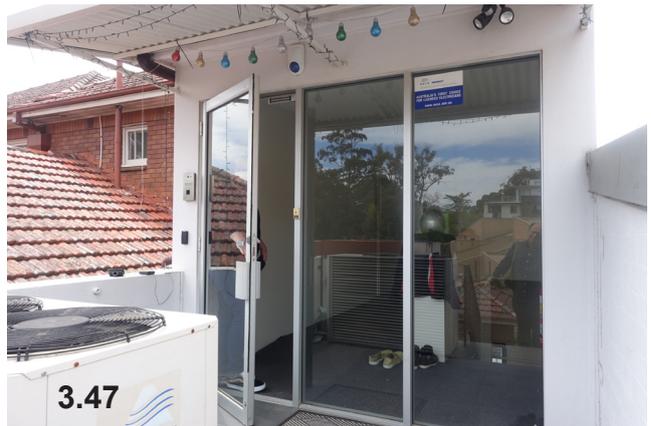
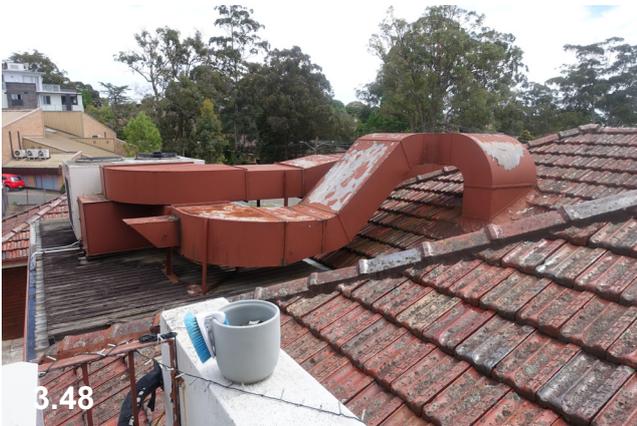
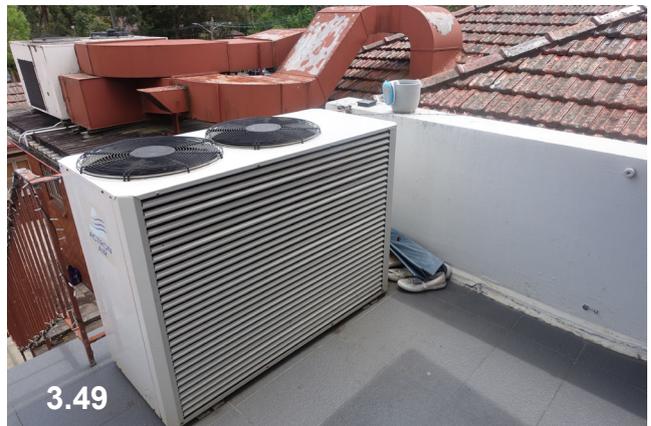
REAR

- 3.44 North-east facade of original garage
- 3.45 North-west facade of original garage
- 3.46 South corner of garage, showing significant cracking
- 3.47 Rear entrance to stairwell off rear terrace
- 3.48 Invasive mechanical ventilation plant and ducts installed 1964
- 3.49 Rear upstairs terrace and air-conditioning unit

The brick boundary wall on the north-east side is bowed and cracked, possibly due to tree roots, and is supported by a metal frame on the garden side. The freestanding brick pier marking the driveway entrance is in poor condition. The garage has significant cracking at the south corner, indicating subsidence. The steps to the front entrance are damaged.
