## LOCAL PLANNING PANEL MEETING

<b>1</b>	<b>LPP31/23</b>	<b>DA/531/2023 - Construction of a Swimming Pool and Covered Deck - 92A Malton Road, Beecroft</b>	
	<b>Attachment 1:</b>	Locality Plan.....	2
	<b>Attachment 2:</b>	Architectural Plans .....	3
	<b>Attachment 3:</b>	Arborist Report v2 .....	12

## ARBORICULTURAL IMPACT ASSESSMENT REPORT

Site Address: 92A Malton Road,  
BEECROFT, NSW, 2119

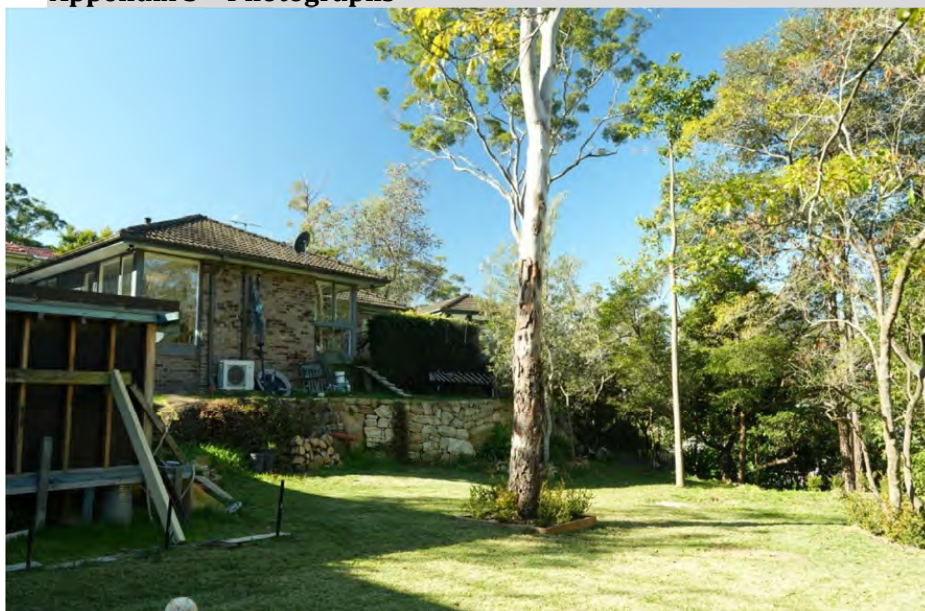
- At the time of assessment, the Arborist considered this tree a candidate for removal irrespective of the development due to poor health.
- 3.4.4 Tree 2, an Illawarra Flame, appeared in good health despite an unusual lack of canopy development to the north of the tree. Foliage on this tree was somewhat chlorotic, but still considered healthy.

*Image 2: The rear yard of the site as seen. Tree 1 featured [centre].*

- 5.1.1 It is recommended that Tree 1 is removed as part of the development application due to the poor health of the tree. As assessed, this tree is a candidate for removal irrespective of the development.
- 5.1.2 It is recommended that Trees 4 and 6 are removed due to poor scores of health and the assessment that the trees are unlikely to recover from their senescent state.
- 5.1.3 The Arborist notes that there is no obligation to remove any of the above trees approved for removal in the Conditions of Consent. The Arborist does not accept any liability resulting from development impacts for a tree recommended for removal.

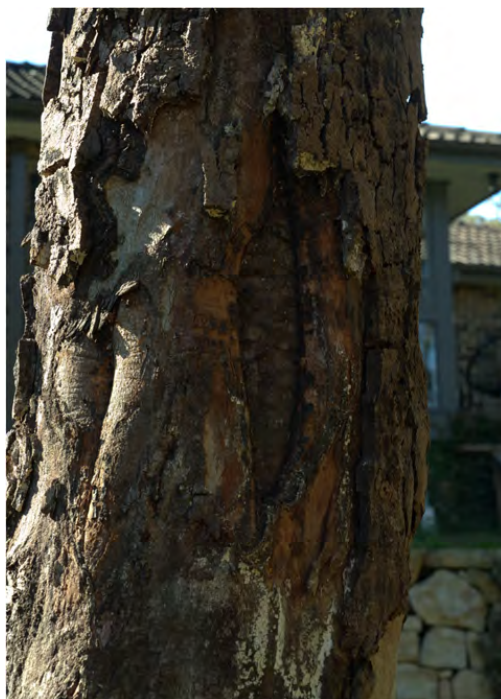
- 3.4.3 Tree 1 was a Grey Gum standing with moderate health and condition. This tree was observed in a state of retrenchment featuring a sparse canopy, cambium injuries to the basal flare and trunk along with signs of longicorn impact.

- The tree appears to have been the subject of a termite attack at some point, evidenced by various flight cuts around the trunk to a height of 3m.
- Weed-matting (or other plastic-based fabric) was noted to be constricting the base of the tree.

*Image 3: Flight cuts and cambium injury to Tree 1.*

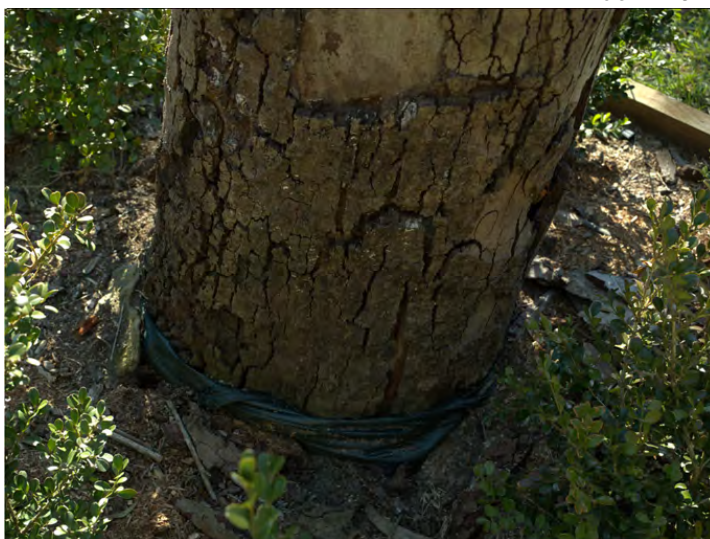
*Image 4: The base of Tree 1 as seen with constriction.*

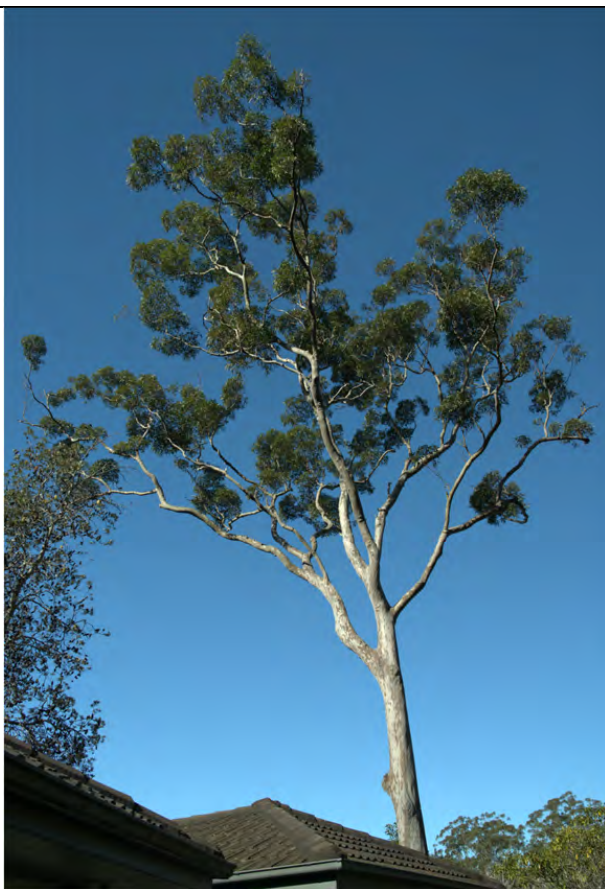
*Image 7: Tree 12 as seen from the rear yard. No impacts are likely to occur throughout construction.*

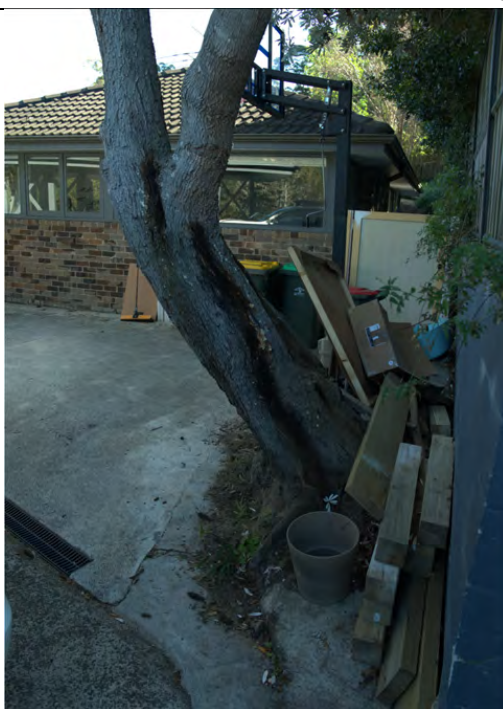
- 3.4.6 Tree 13 was noted to contain signs of kino staining of the lower trunk to approximately 2 metres above ground level. The tree, with trunk lean slightly to the west, appeared to be mostly stable despite evidence of root cuts at the base of the tree & a reduced soil volume for future growth.

*Image 8: Tree 13 as seen. The protection of this tree may prove to be a challenge.*
