CONSERVATION MANAGEMENT PLAN

370 Pennant Hills Road, Pennant Hills

Issue D, July 2022

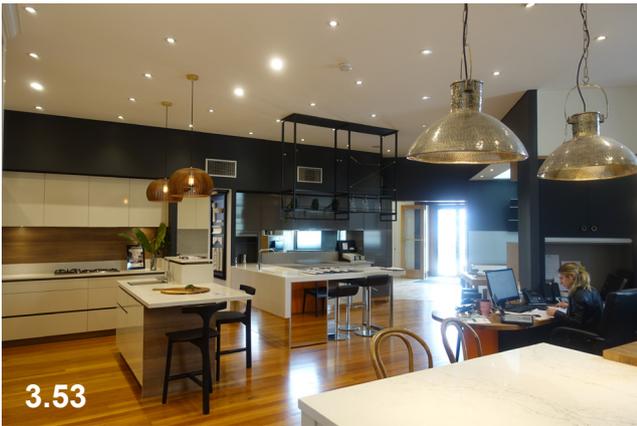
3.53 Looking south-east towards entrance (G1)

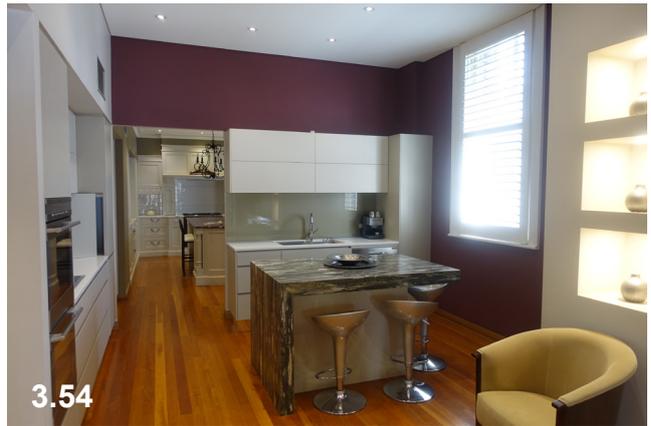
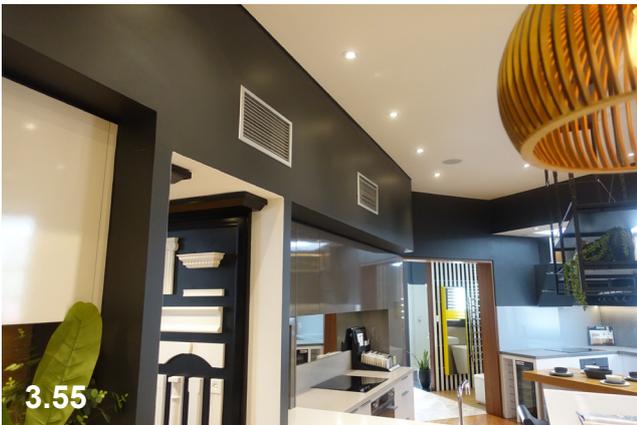
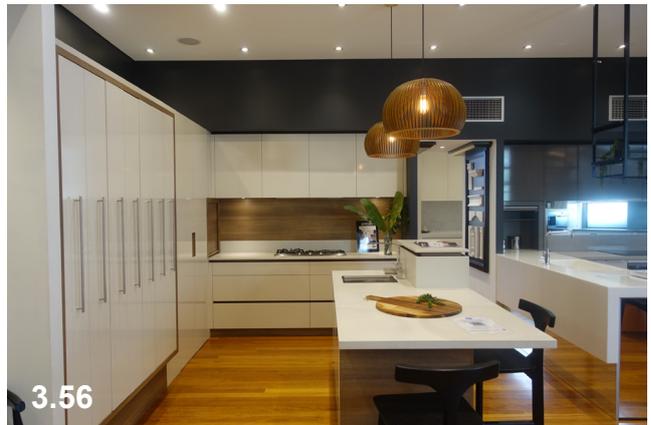
3.54-56 Typical showroom areas (G1)

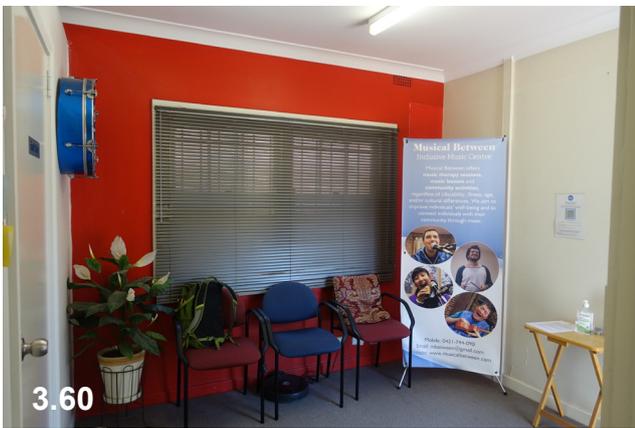
- 3.60 Entry/waiting room (G5)
- 3.61 Partition between G5 and G6
- 3.62 Music Room, (G8)
- 3.63 Non-original windows in north-west wall of Music Room (G8)

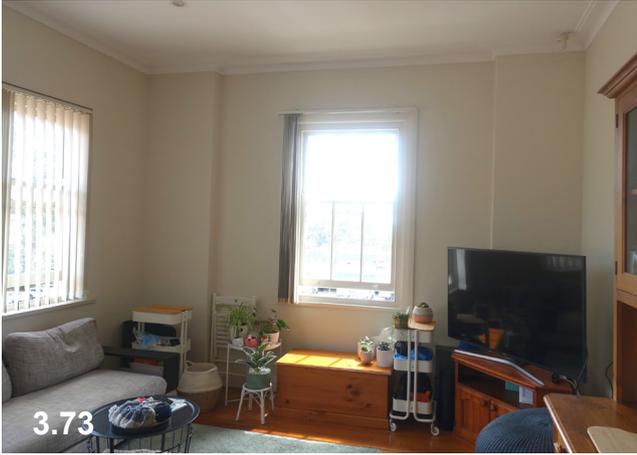
- 3.73 Living Room (F5)
- 3.74 North-west window of Living Room (F5)
- 3.75 Typical window (F5) facing Fisher Avenue
- 3.76 Typical 3-panel door (F5)
- 3.77 Typical original door hardware (F5)
- 3.78 Typical ceiling detail (F5)
- 3.79 Hallway (F6) looking towards front door
- 3.80 Kitchen (F4)
- 3.81 Bathroom (F3)
- 3.82 Toilet (F2)
- 3.83 Typical original doorway (F3/F6)

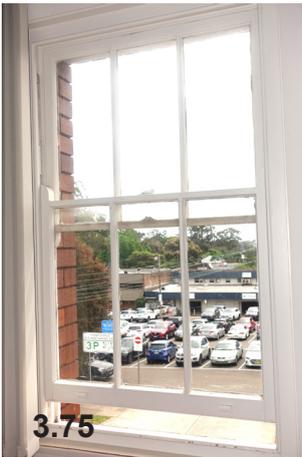
3.75

While original timber double hung windows have been retained, their external surfaces are in poor condition, requiring painting at the least and possibly repair in places.

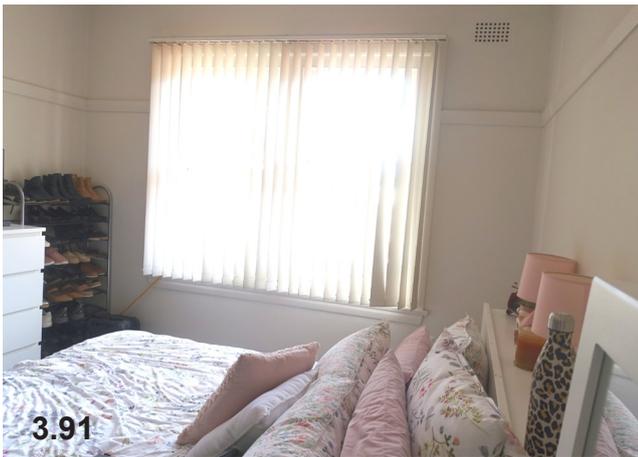
- 3.91 Bedroom (F1)
- 3.92 Bedroom (F5)
- 3.93 Typical original window facing Pennant Hills Road (F8)
- 3.94 Window detail with fixed secondary glazing indicated by arrow (F8)
- 3.95-96 Combined Bathroom/laundry Toilet (F7)
- 3.97 Typical ceiling
- 3.98 Typical skirting
